NAVAL AIR TRAINING COMMAND

**ELECTRICAL SYSTEM: A.C. DISTRIBUTION
AND AIRCRAFT SERVICE CHANGE 36**

**T-28 ENGINEERING
PRIMARY**

UNIT: Electrical System: A.C. Distribution and Aircraft Service Change 36, NATIP System Unit

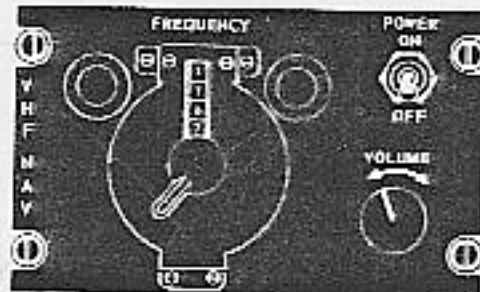
VHF NAV CONTROL PANEL
(TACAN NOT INSTALLED)

TACAN requires a significant a.c. capability for operation. This a.c. requirement exceeded the system capacity of the original configuration of the T-28. The small inverter would not carry the TACAN by itself, but it would carry the a.c. bus. The large inverter would not carry both TACAN and the a.c. bus, but would handle the TACAN with ample reserve capacity. If the T-28 has TACAN installed (figure 2) then it has ASC 36.

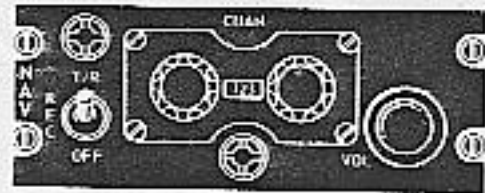
FIGURE 2

TACAN CONTROL PANEL
(ASC 36 installed)
